DESIGN OF READYMADE GARMENTS INDUSTRY FOR FIRE SAFETY

A Dissertation for the Degree of Master in Disaster Management

By
AHSAN FIROZ
10268004

Postgraduate Programs in Disaster Management (PPDM)
BRAC University

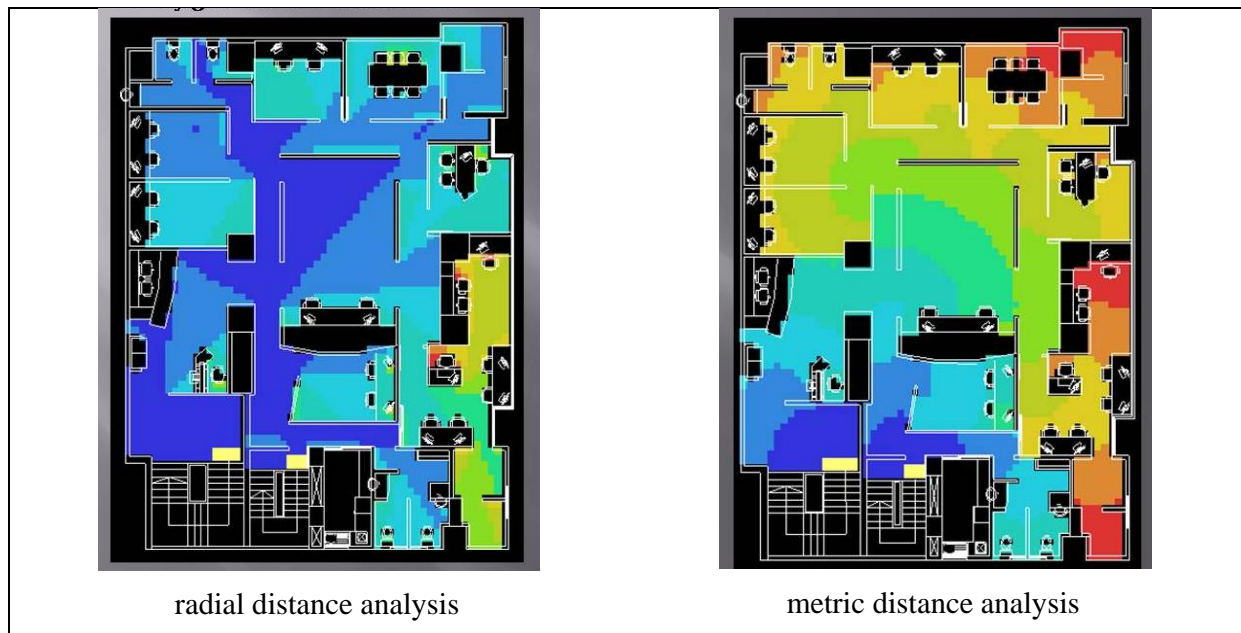
Figure 3, Difference between radial and metric analysis

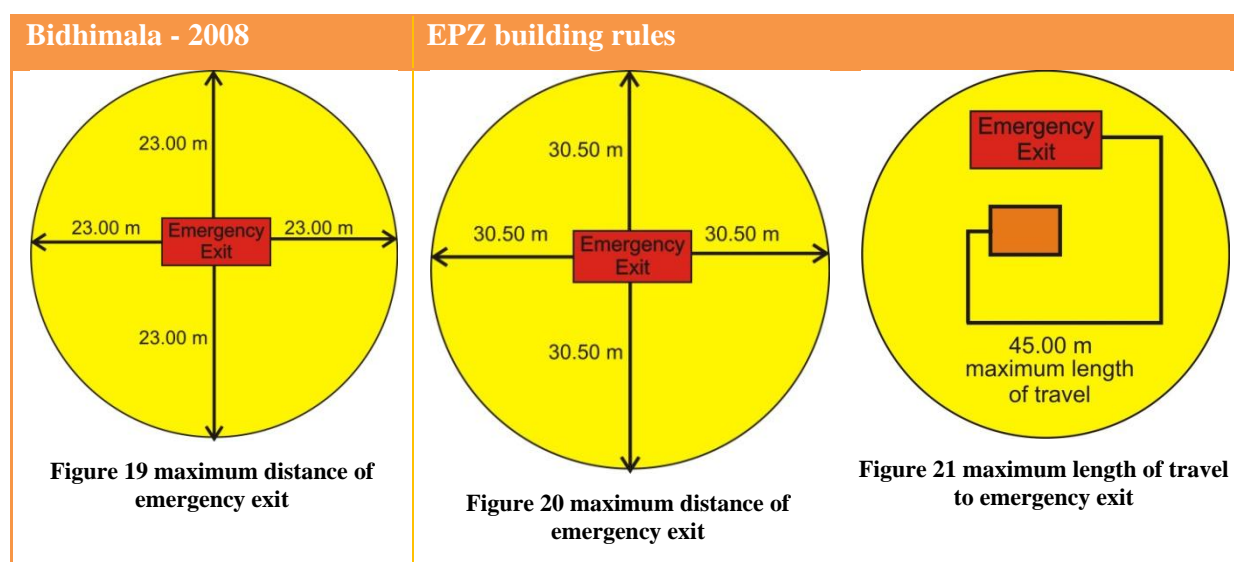
Figure 22, Illustrations showing difference between Bidhimala - 2008 and EPZ building rules

The different rules for positioning of emergency exit are further described by the illustrations below.

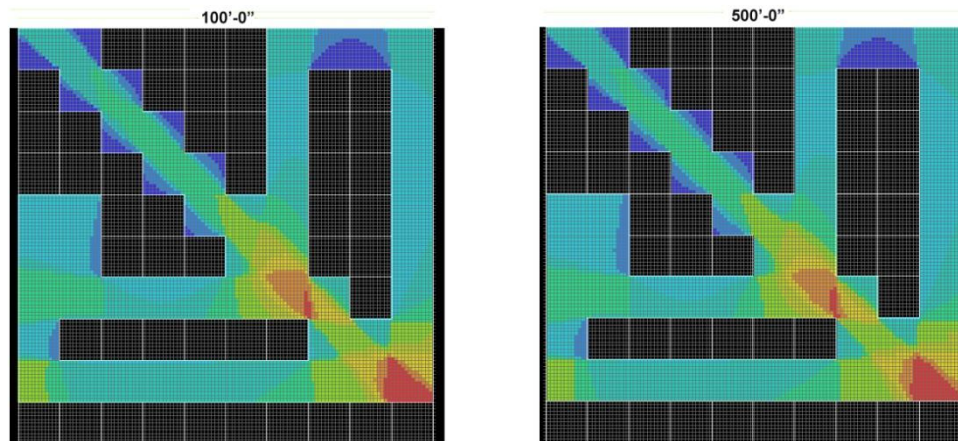
Figure 35 Comparison between two similar plans with different scale (no difference in shading as the analysis was run on a relative scale of individual plans)

Steps 1-6 shown above are basic steps of analysis. Here the software works on a comparative basis i.e. it creates the color shade based on its own understanding of the plan given for analysis. For example, it would give a red shade to the apparently most distant part of the plan from the exit. The output as mentioned above may not also be considered incorrect as well; although the analysis is based on the understanding of the software itself in relation to the whole area of the given plan. The same color shading may be found if two similar plans are given for analysis with their scales different as shown in Figure 35.

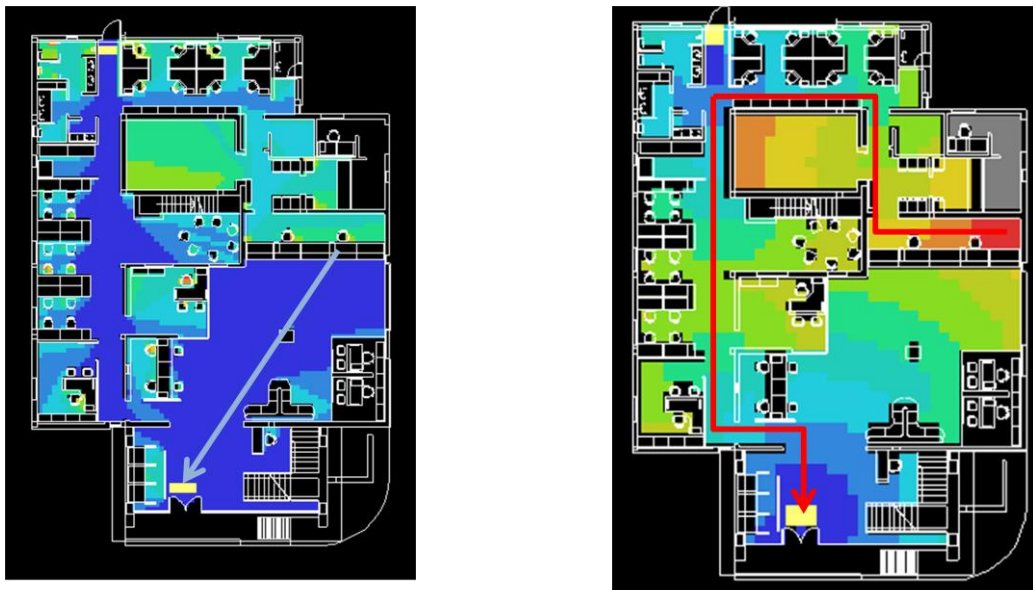
Figure 36, Difference between visibility and metric analysis

In this research, it is exposed that, although the distance from the starting point to egress point may quite be within the limits of existing standards and codes, the results may not be sufficient enough to avoid vulnerability. The main reason of this situation may be the relationship of the functional usage and the dimensional distance to the egress point. The model emphasizes that human factor, geometrical structure and the space syntax inputs are especially effective for the evaluation of evacuation vulnerability.

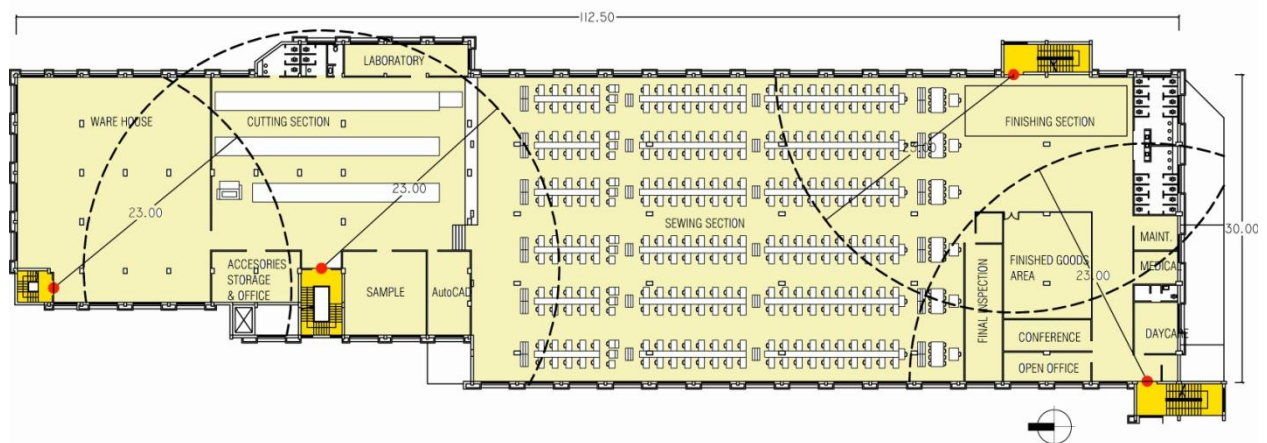
Figure 42, Case Study 01: Floor Plan

Basic Facts	
Floor area	3,100 sqm
Floor population	~433
Area per person	7.16 sqm
Gross area per person ²⁸ according to law	10.00 sqm
No. of exits	04
No. of emergency exit ²⁹	04

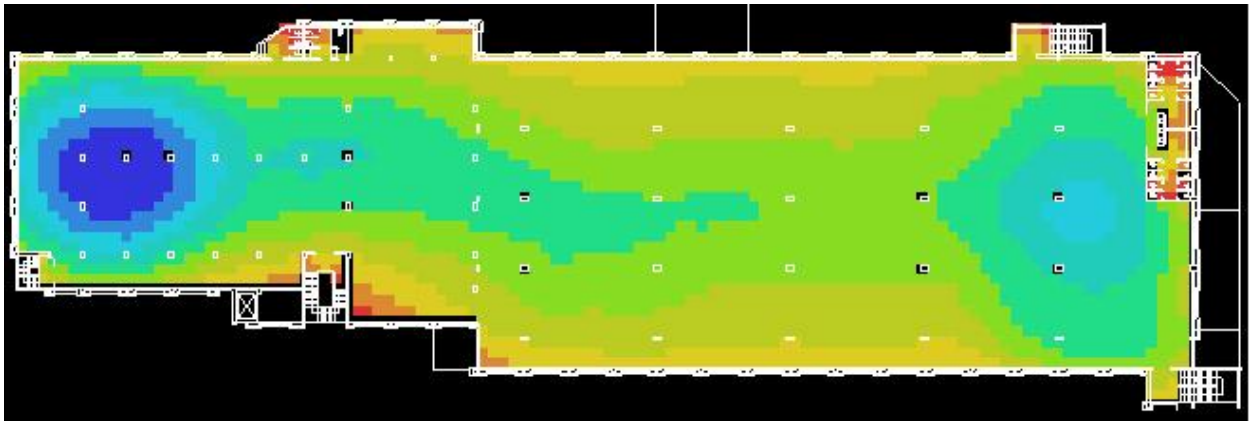
Figure 43, Case Study 01: default metric distance analysis

An open floor, default metric distance graph is shown above. Since there is no obstacle on the floor, the color scheme is mostly in the shades of blue and green, suggesting no or very little risk zones over the floor.

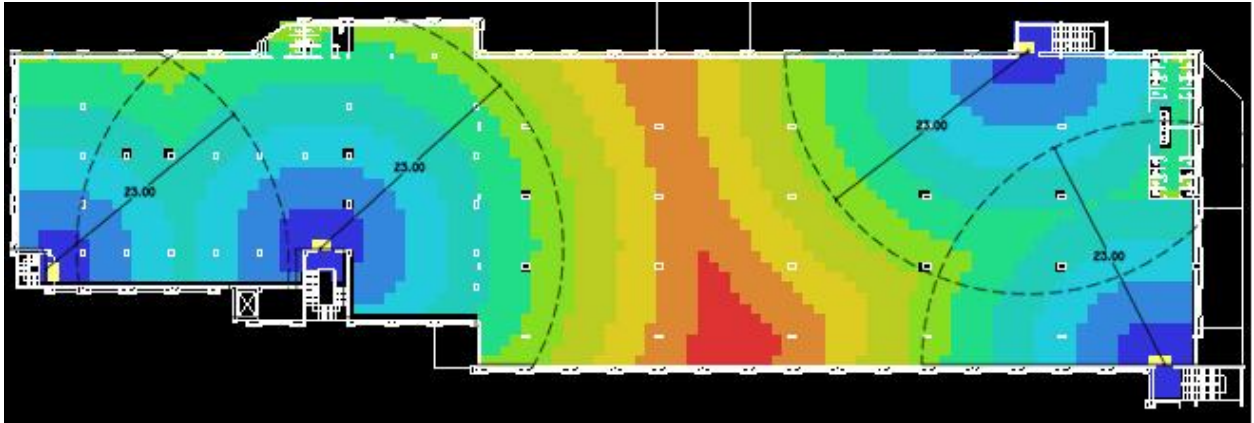
Figure 44, Case Study 01: open floor metric stepdepth with visibility graph set to 23

The open floor plan is studied here. The input radial distance for metric analysis is set at 23 m. here it is clearly evident that the middle portion of the floor is outside the 23 m radial range of the emergency exits. All the areas outside the safe radius of the egress point are shown in shades of yellow (comparatively least vulnerable areas) to red (most vulnerable area).

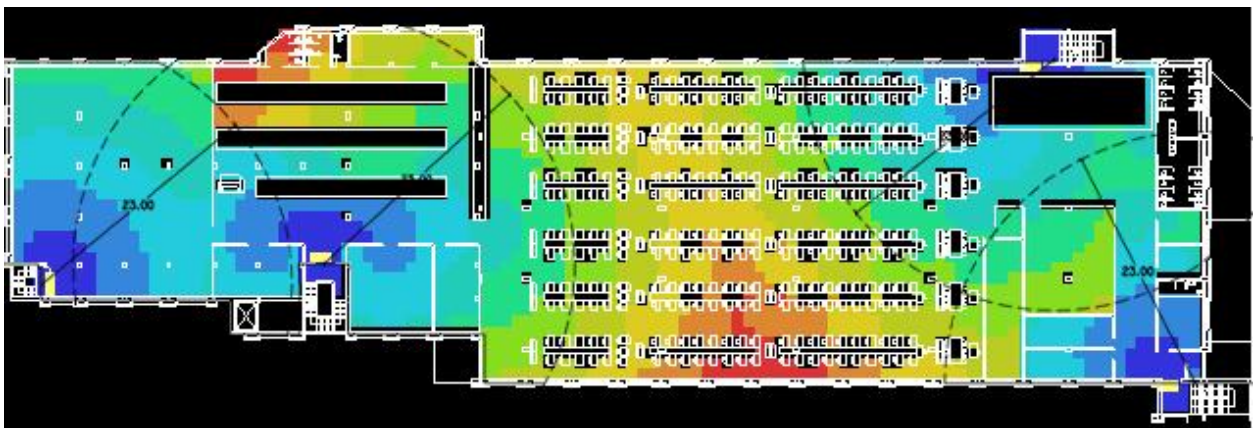
Figure 45, Case Study 01: metric stepdepth with furniture and machine layout

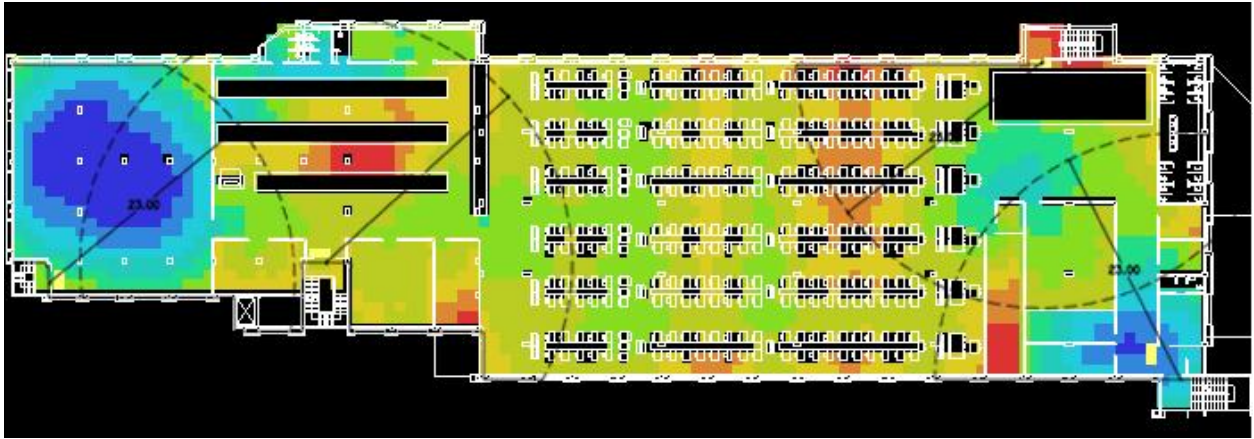
Figure 46, Case Study 01: Visibility graph analysis

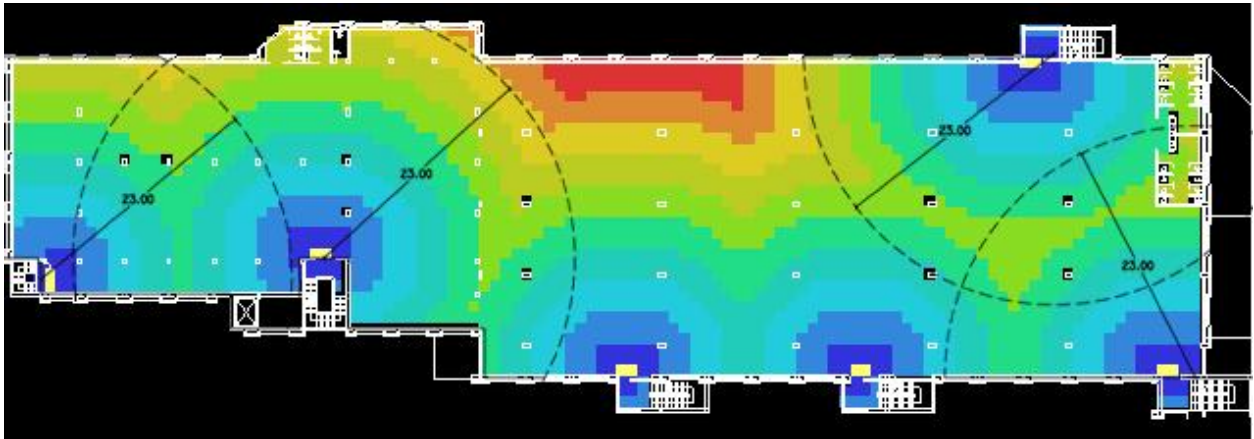
Figure 47, Case Study 01: adding two more emergency exit to the floor

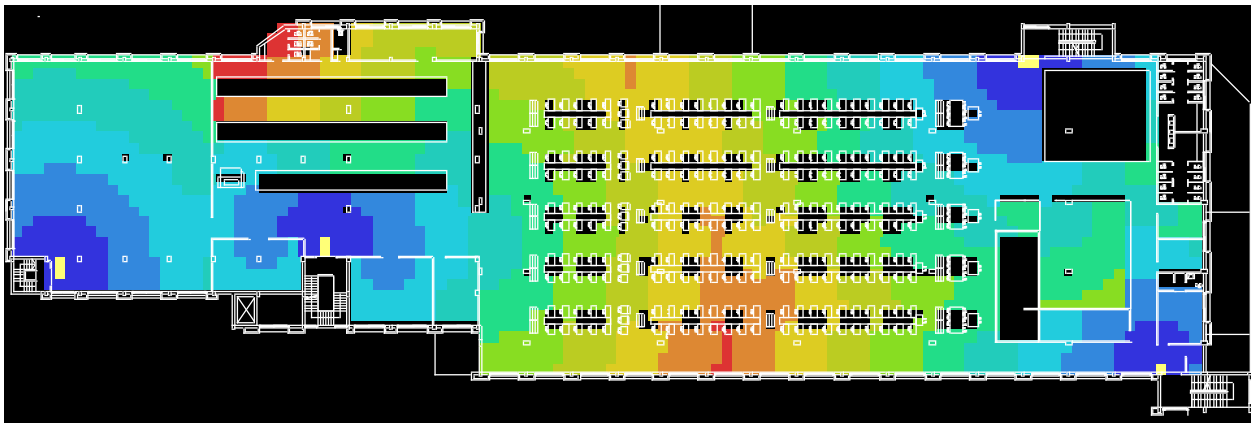
Figure 48, Case Study 01: metric step depth analysis with reduced density

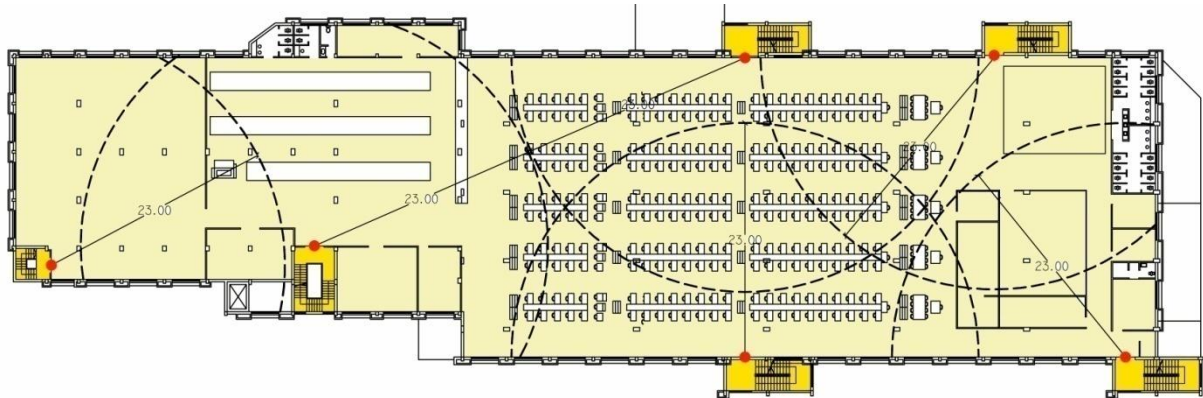
Figure 49, Case Study 01: altered plan

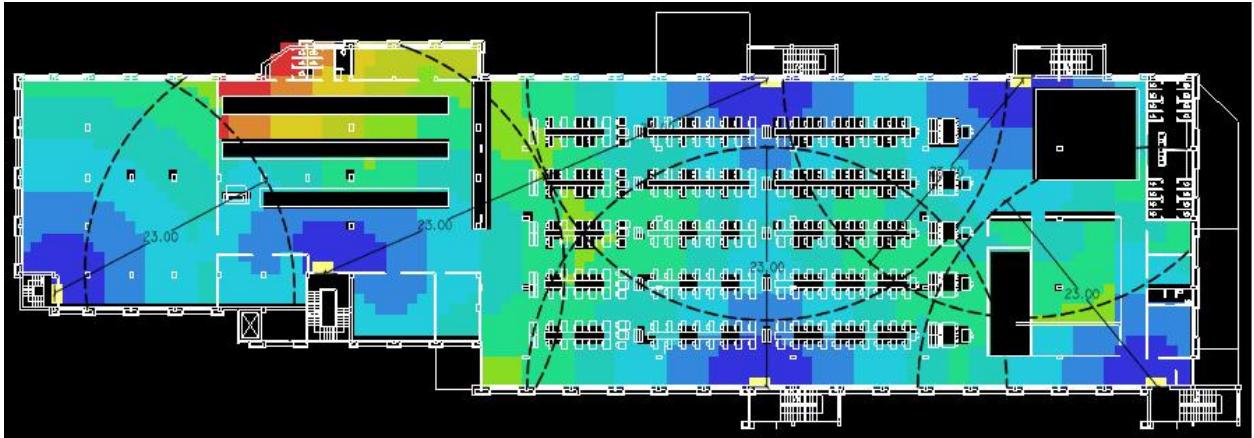
Figure 50, Case Study 01: metric step depth analysis (revised plan)

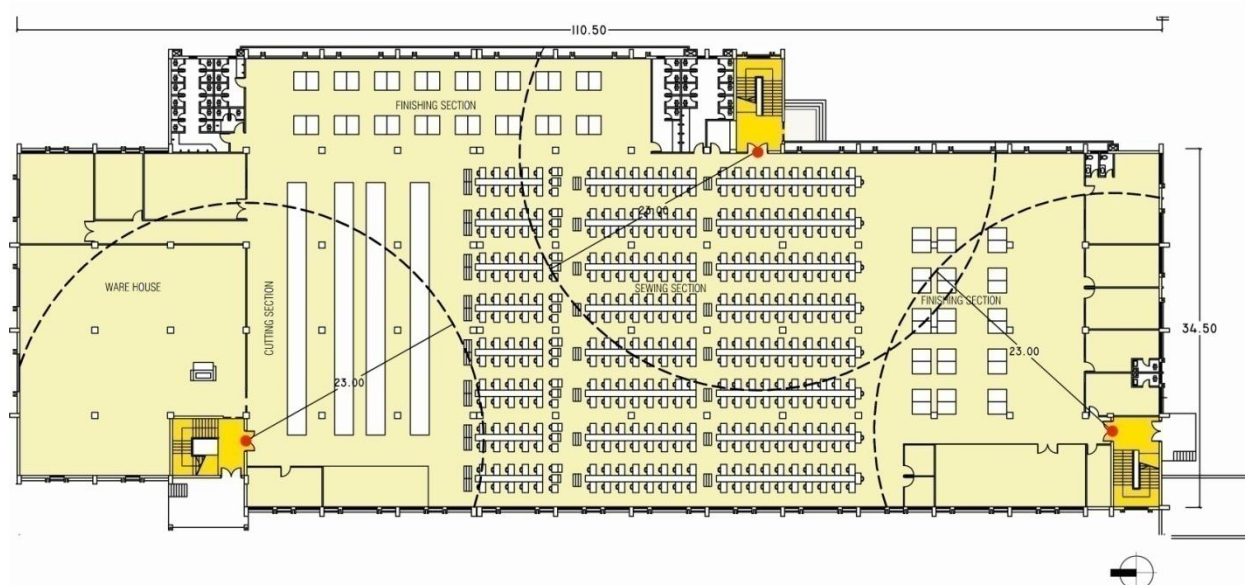
Figure 51, Case Study 02: Floor plan

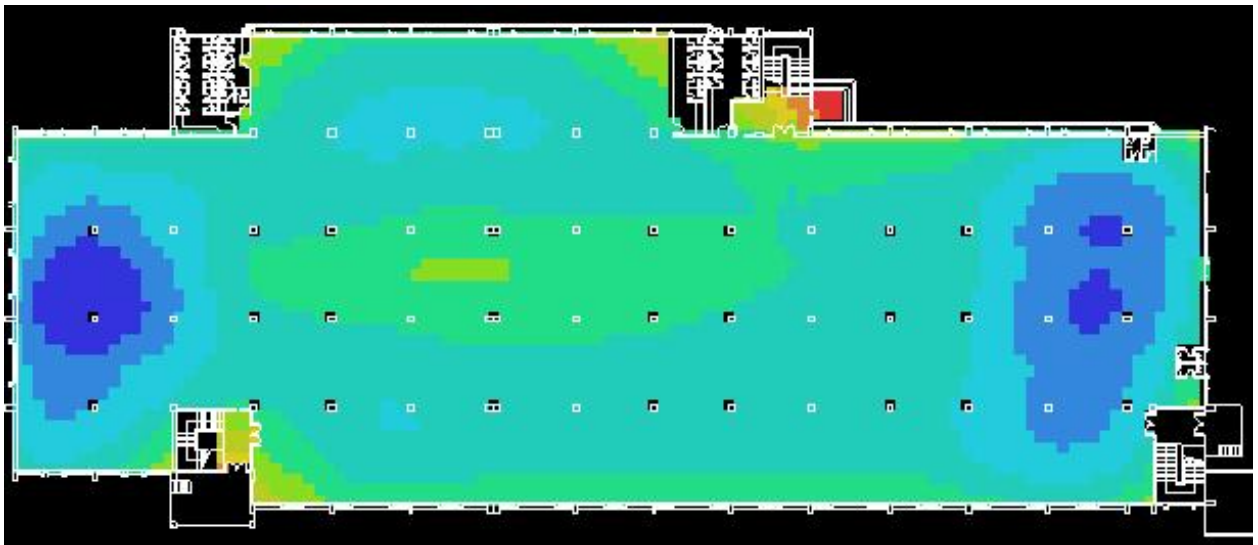
Figure 52, Case Study 02: Default visibility graph analysis

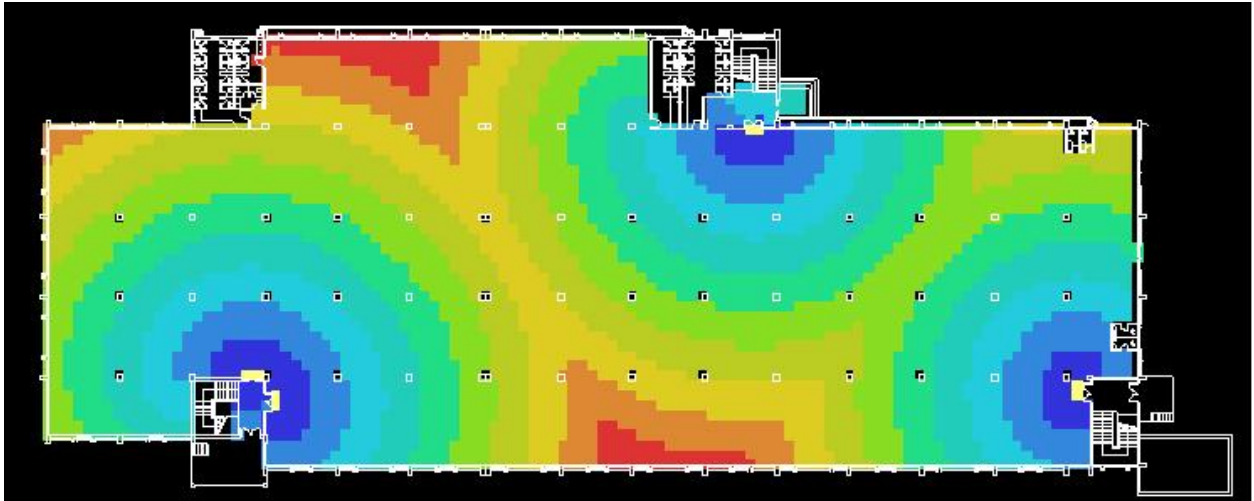
Figure 53, Case Study 02: Step depth analysis from selected location

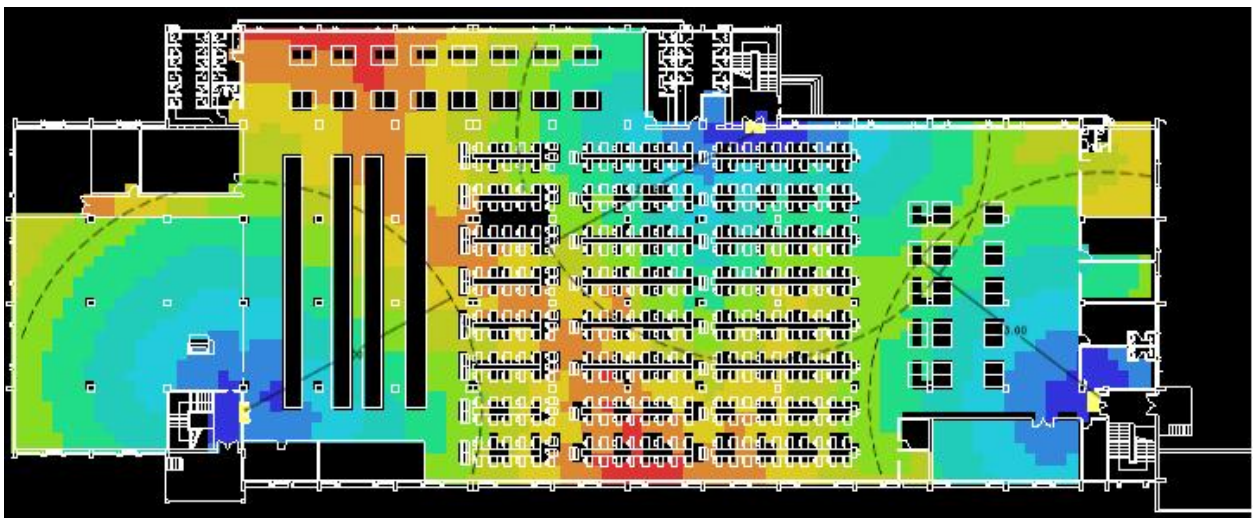
Figure 54, Case Study 02: Metric stepdepth with furniture and machine layout

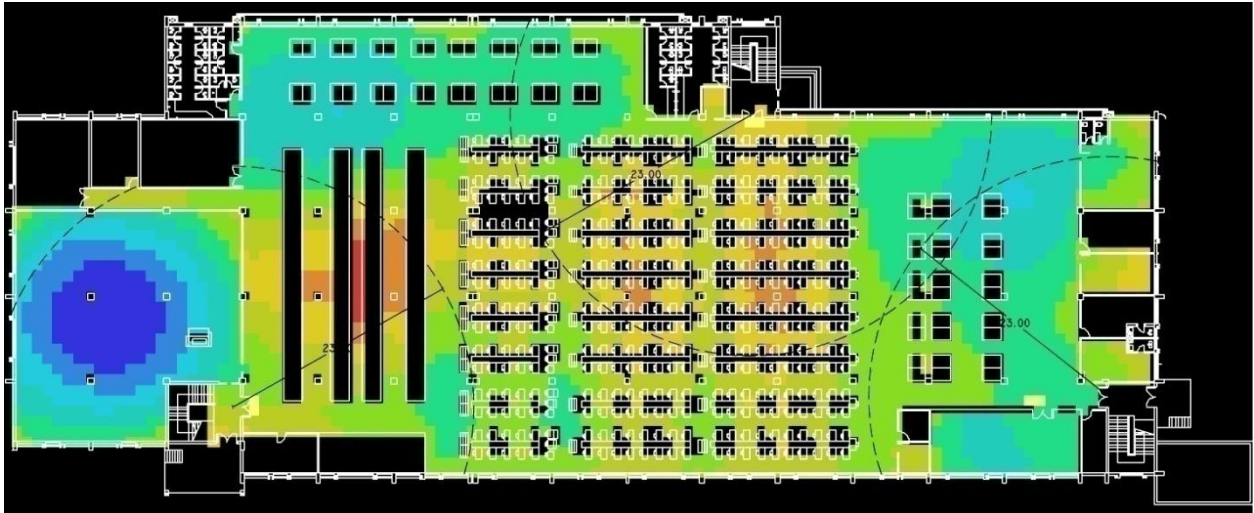
Figure 55, Case Study 02: Visibility graph analysis

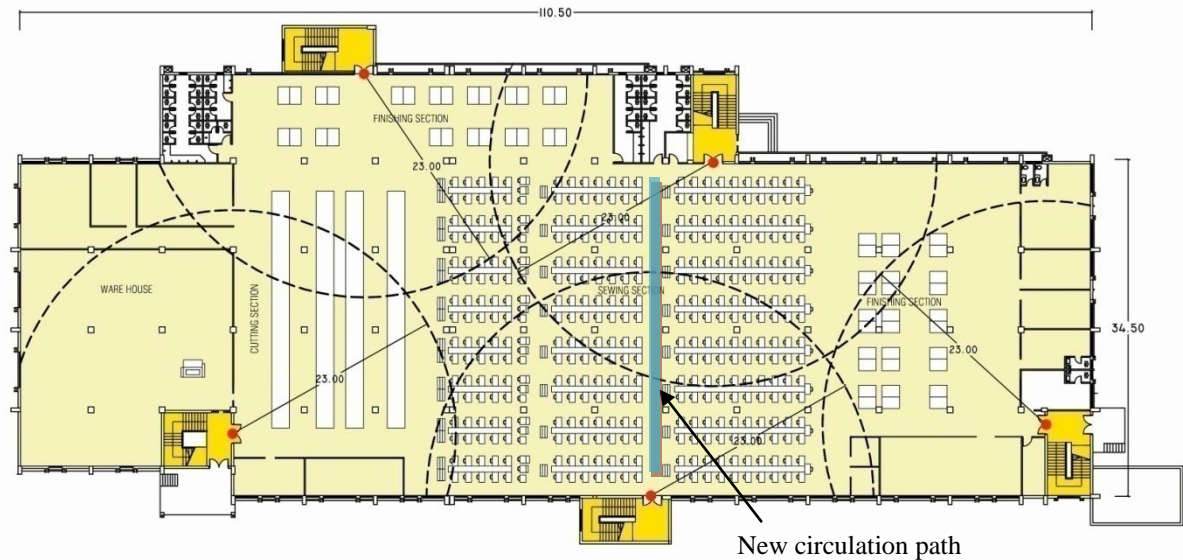
Figure 56, Case Study 02: Altered plan

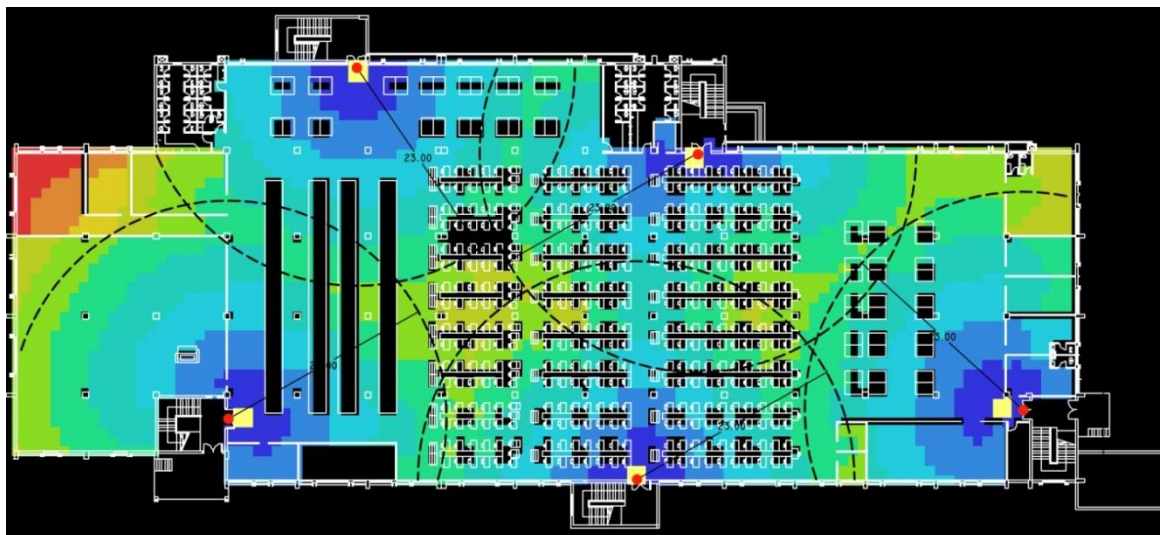
Figure 57, Case Study 02: Revised visibility step depth

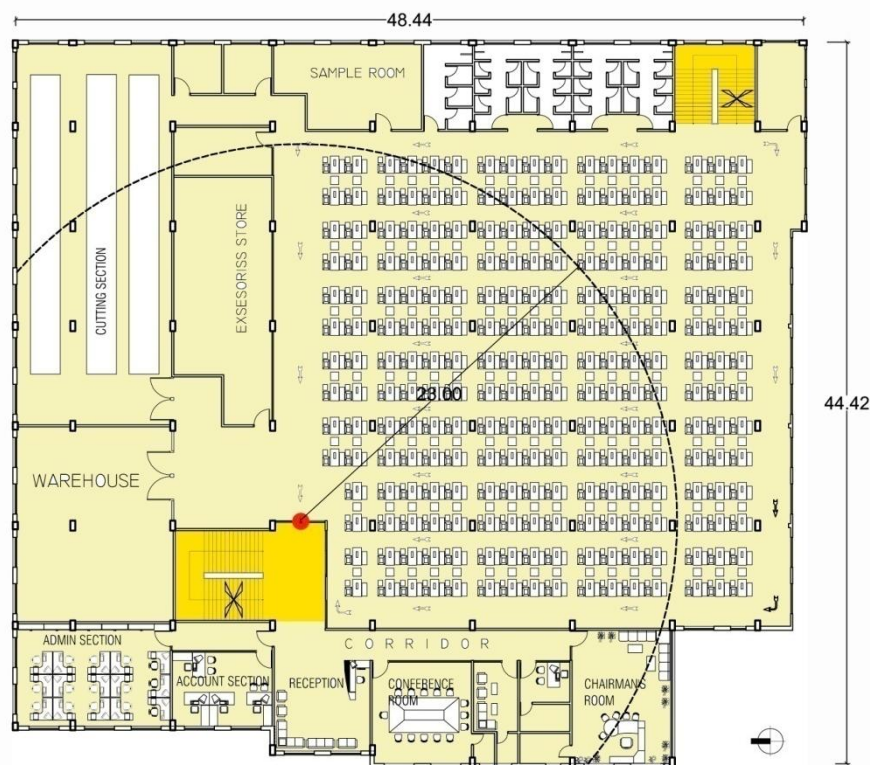
Figure 58, Case Study 03: Floor Plan

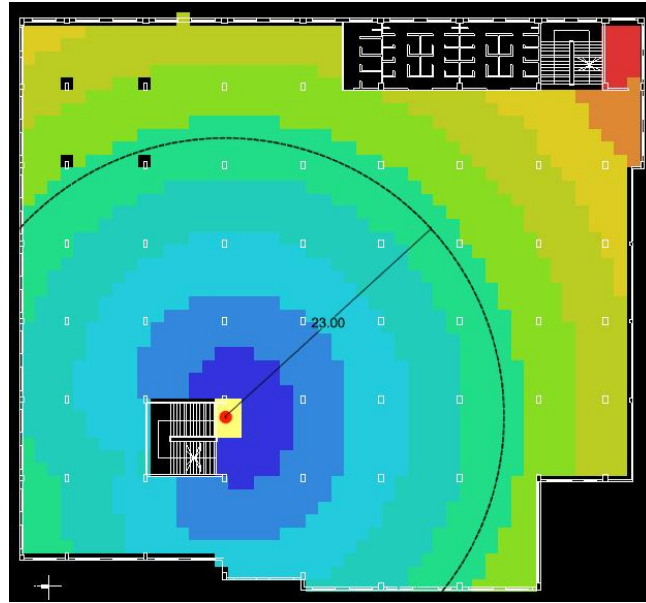
Figure 60, Case Study 03: Open floor metric step depth analysis

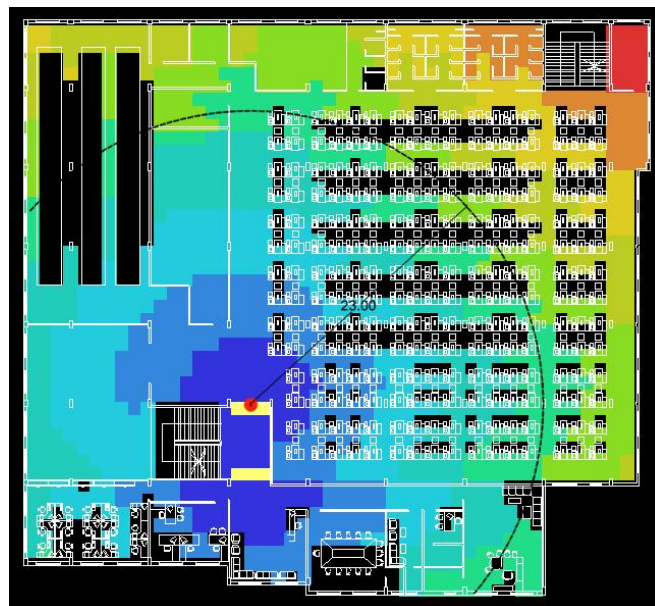
Figure 61, Case Study 03: Metric step depth analysis

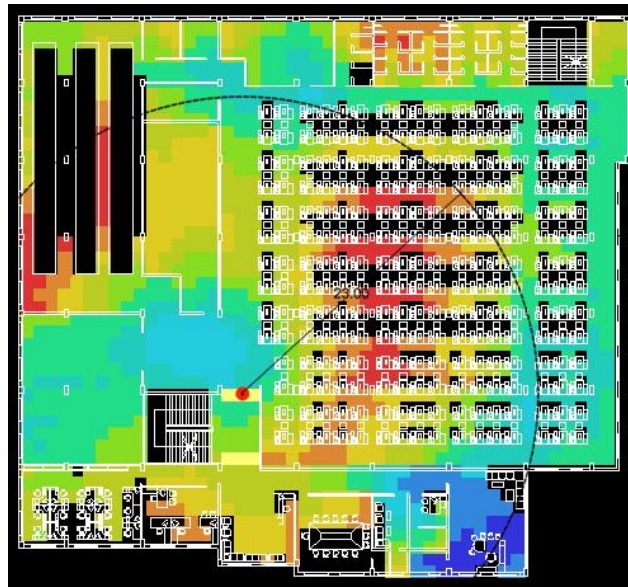
Figure 62, Case Study 03: Visibility graph analysis

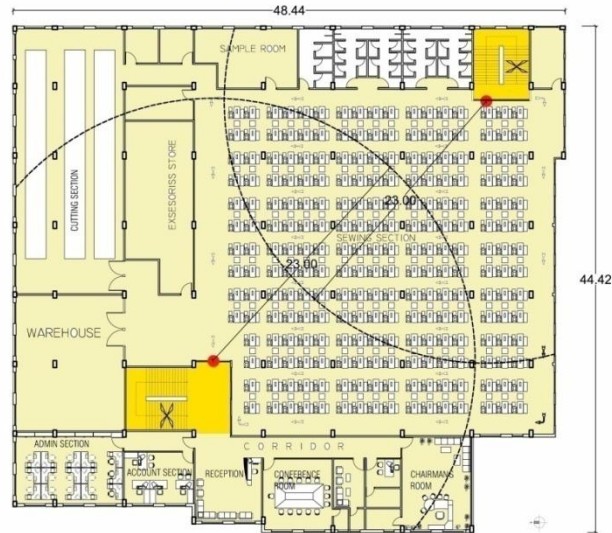
Figure 63, Case Study 03: Altered plan

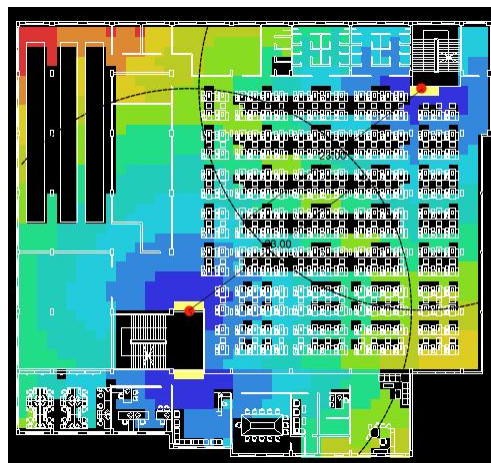
Figure 64, Case Study 03: Metric step depth analysis with altered plan

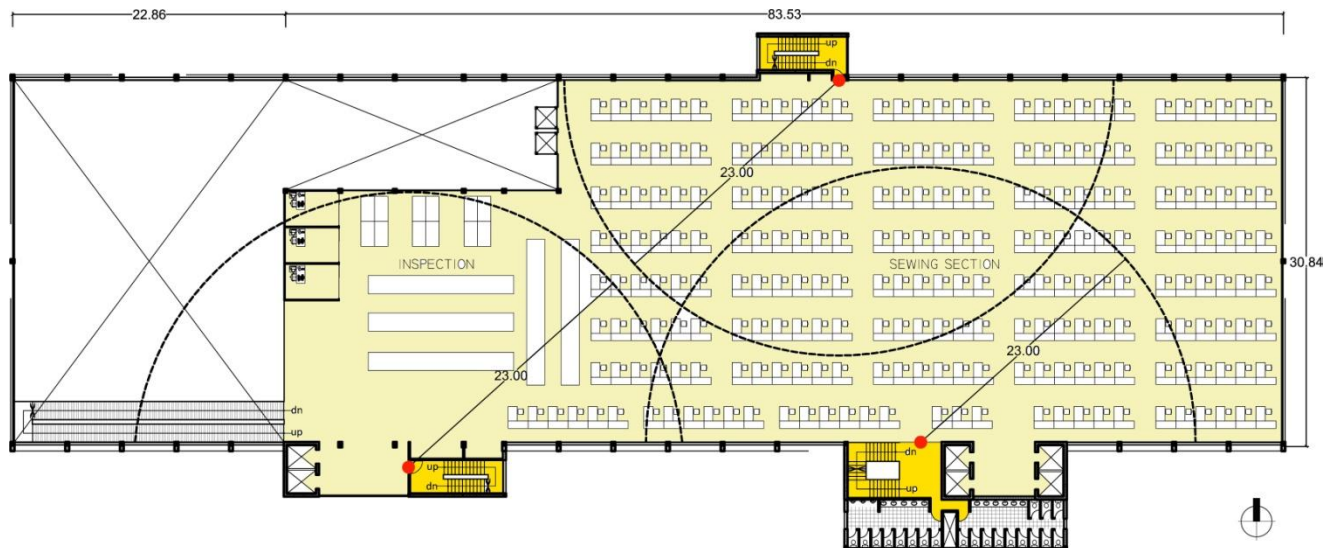
Figure 65, Case Study 04: Floor Plan

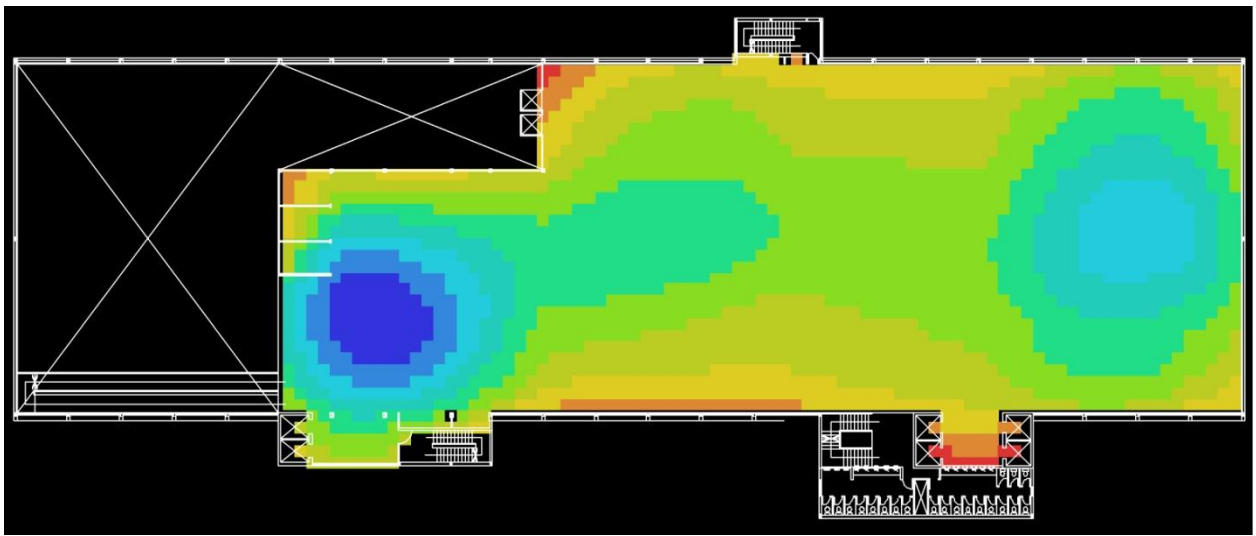
Figure 66, Case Study 04: Open plan, visibility analysis (23 m)

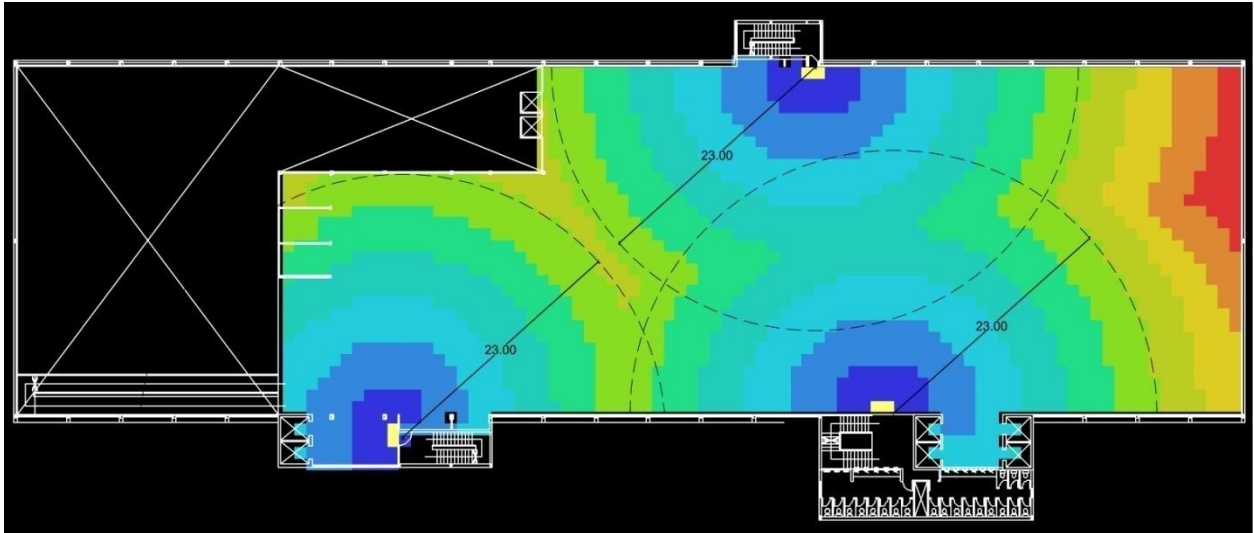
Figure 67, Case Study 04: Metric Step depth analysis of open floor from selected locations

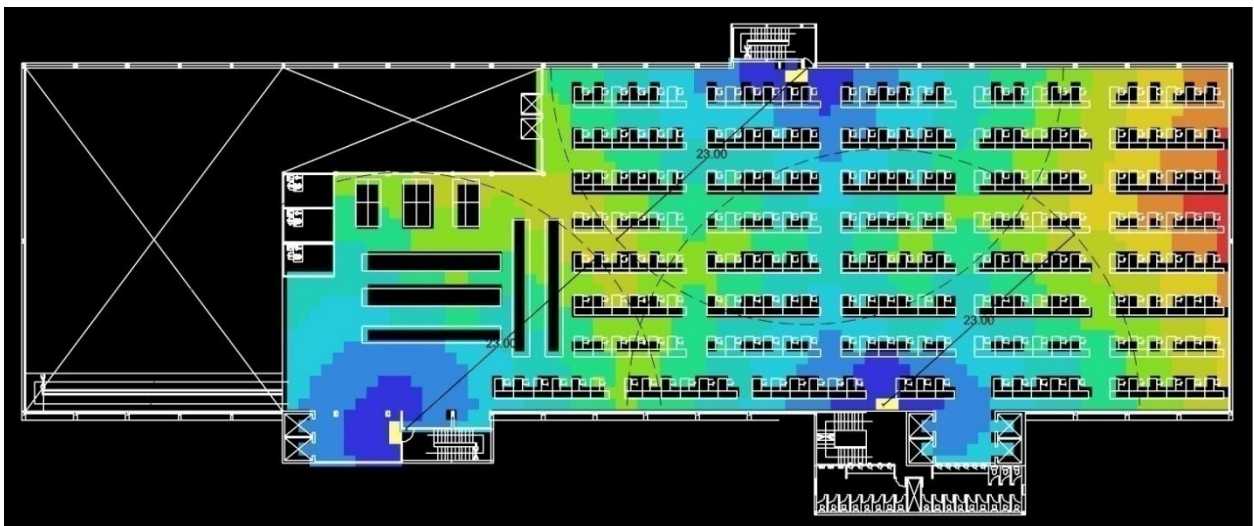
Figure 68, Case Study 04: Metric step depth analysis of designed floor from selected locations

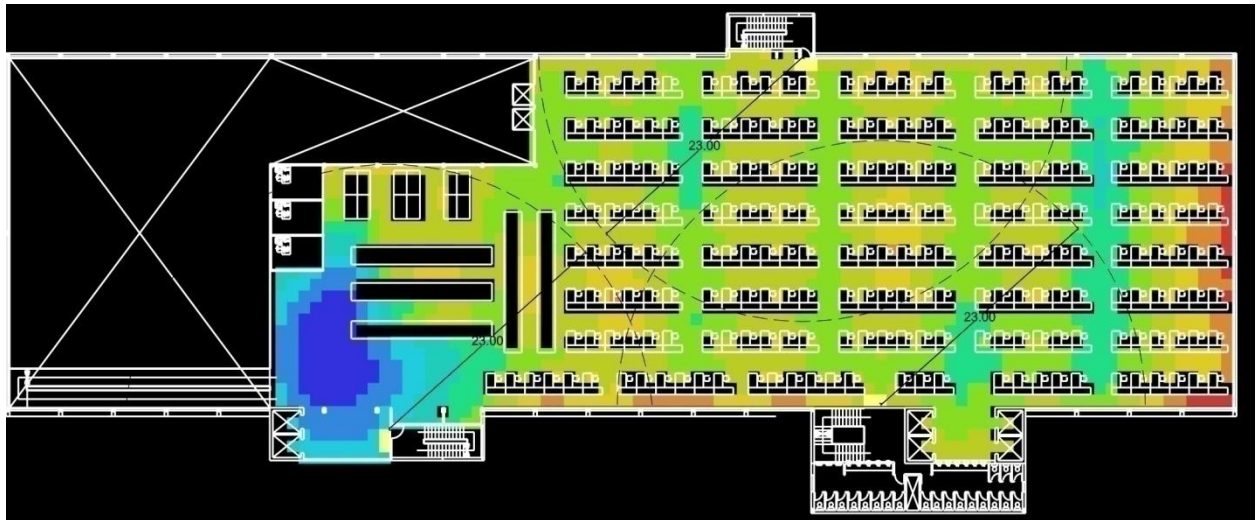
Figure 69, Case Study 04: Visibility graph analysis (23m)

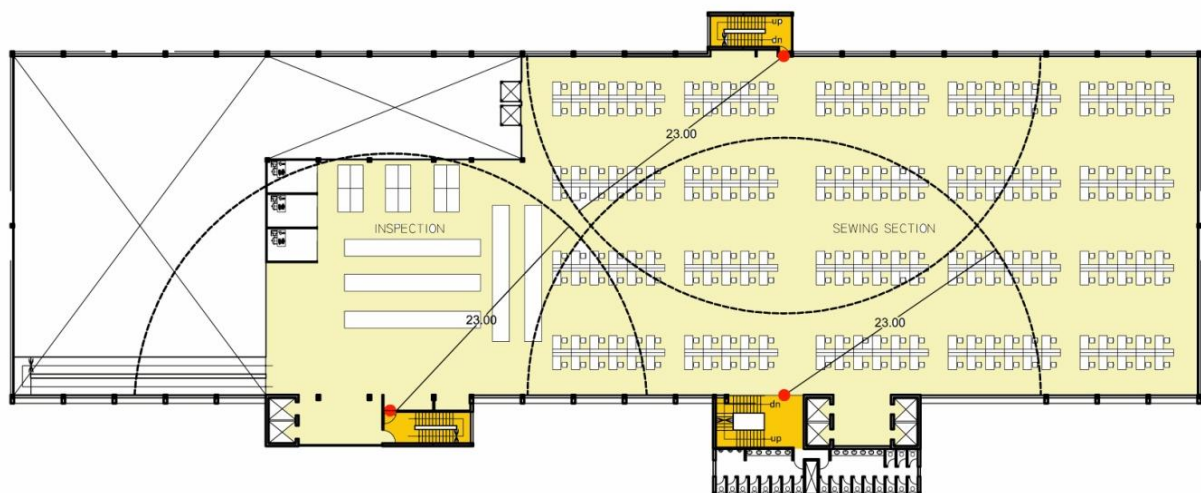
Figure 70, Case Study 04: Altered Plan

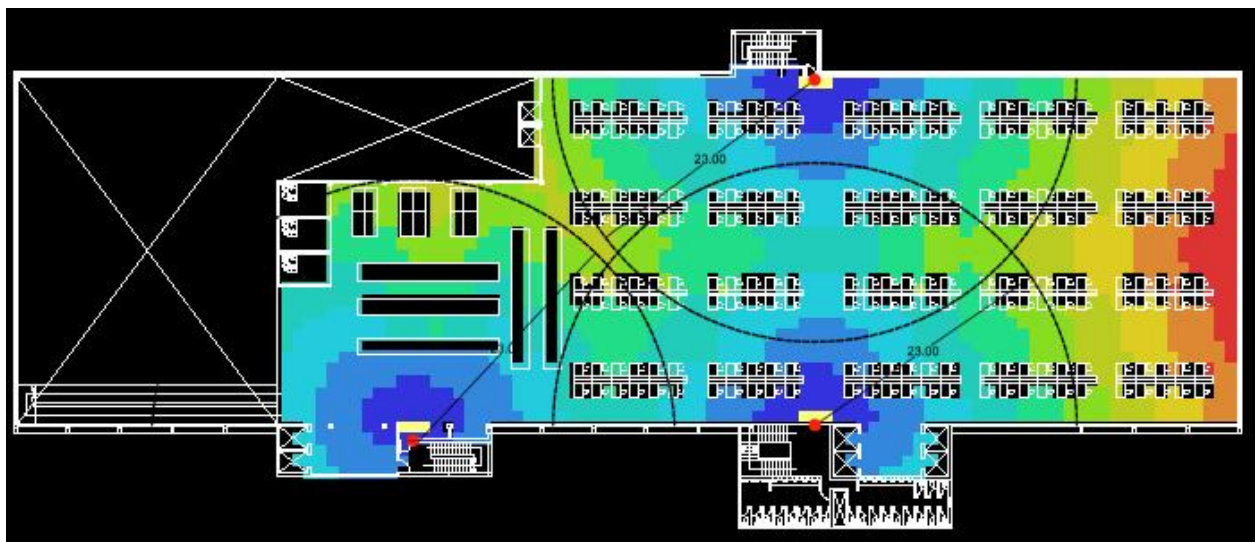
Figure 71, Case Study 04: Metric stepdepth analysis (altered plan)

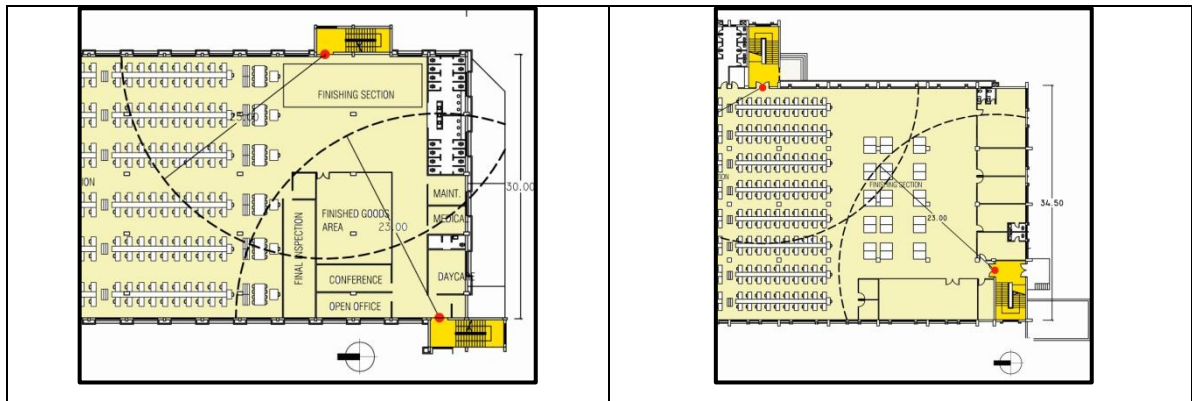
Figure 74, Inefficient catchment radii of emergency exits

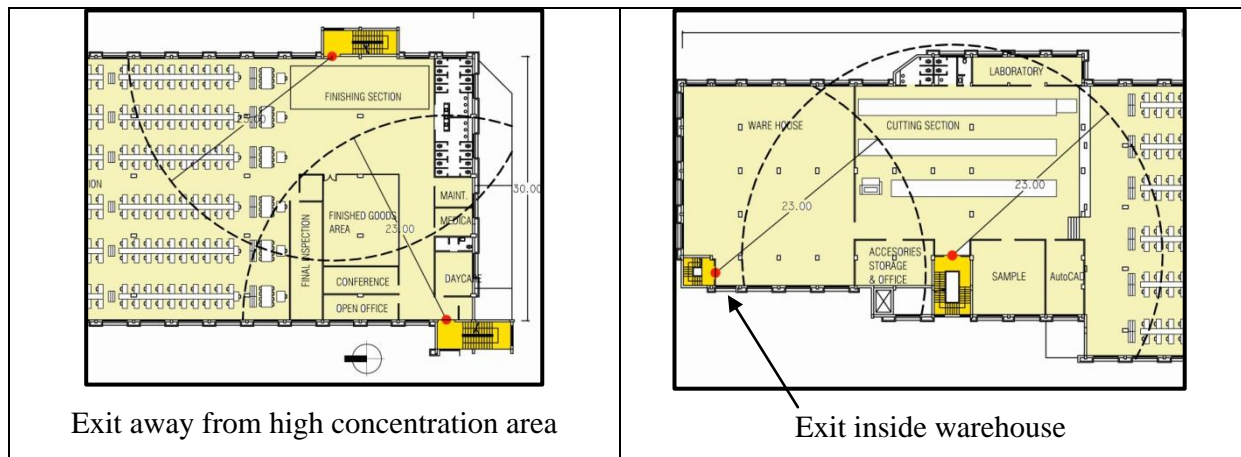
Figure 76, Improper exit locations

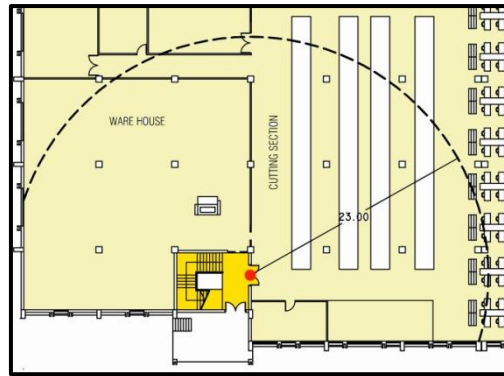
Figure 77, Proper location of exit

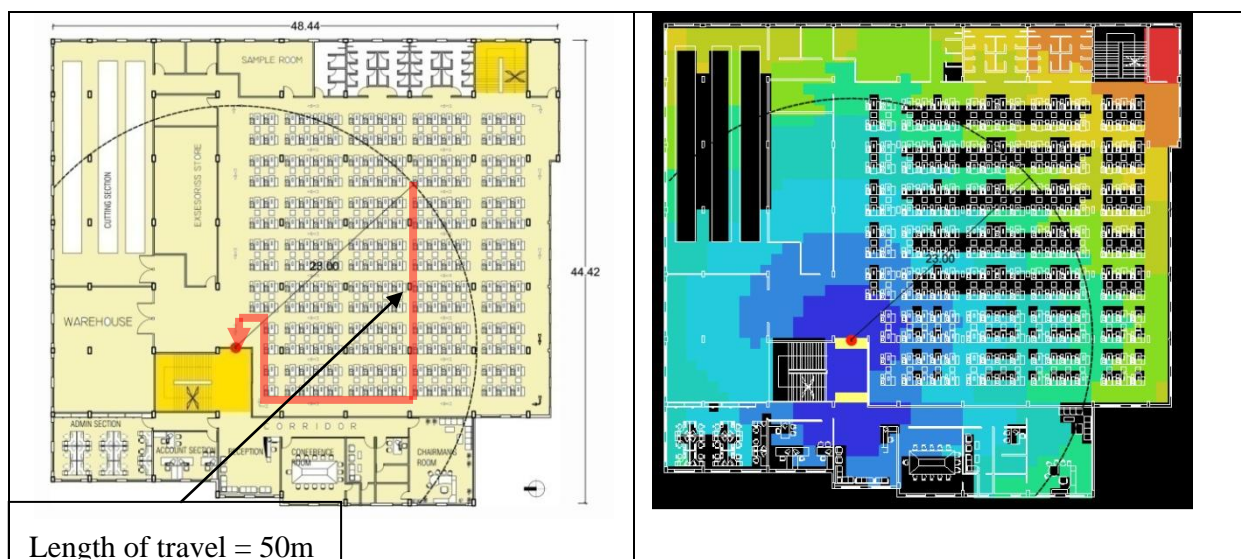
Figure 78, Higher length of travel and corresponding metric step depth graph

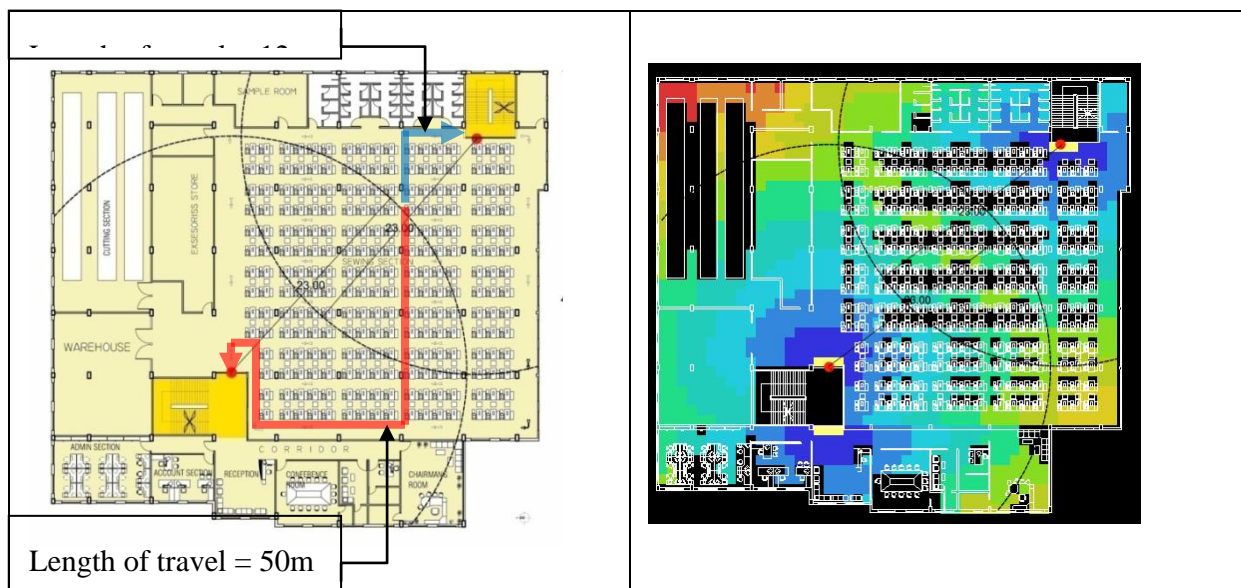
Figure 79, Altered plan and its corresponding metric step depth analysis
